# Dropsonde Data Quality Control:

## *PREDICT*

June Wang and Kate Young

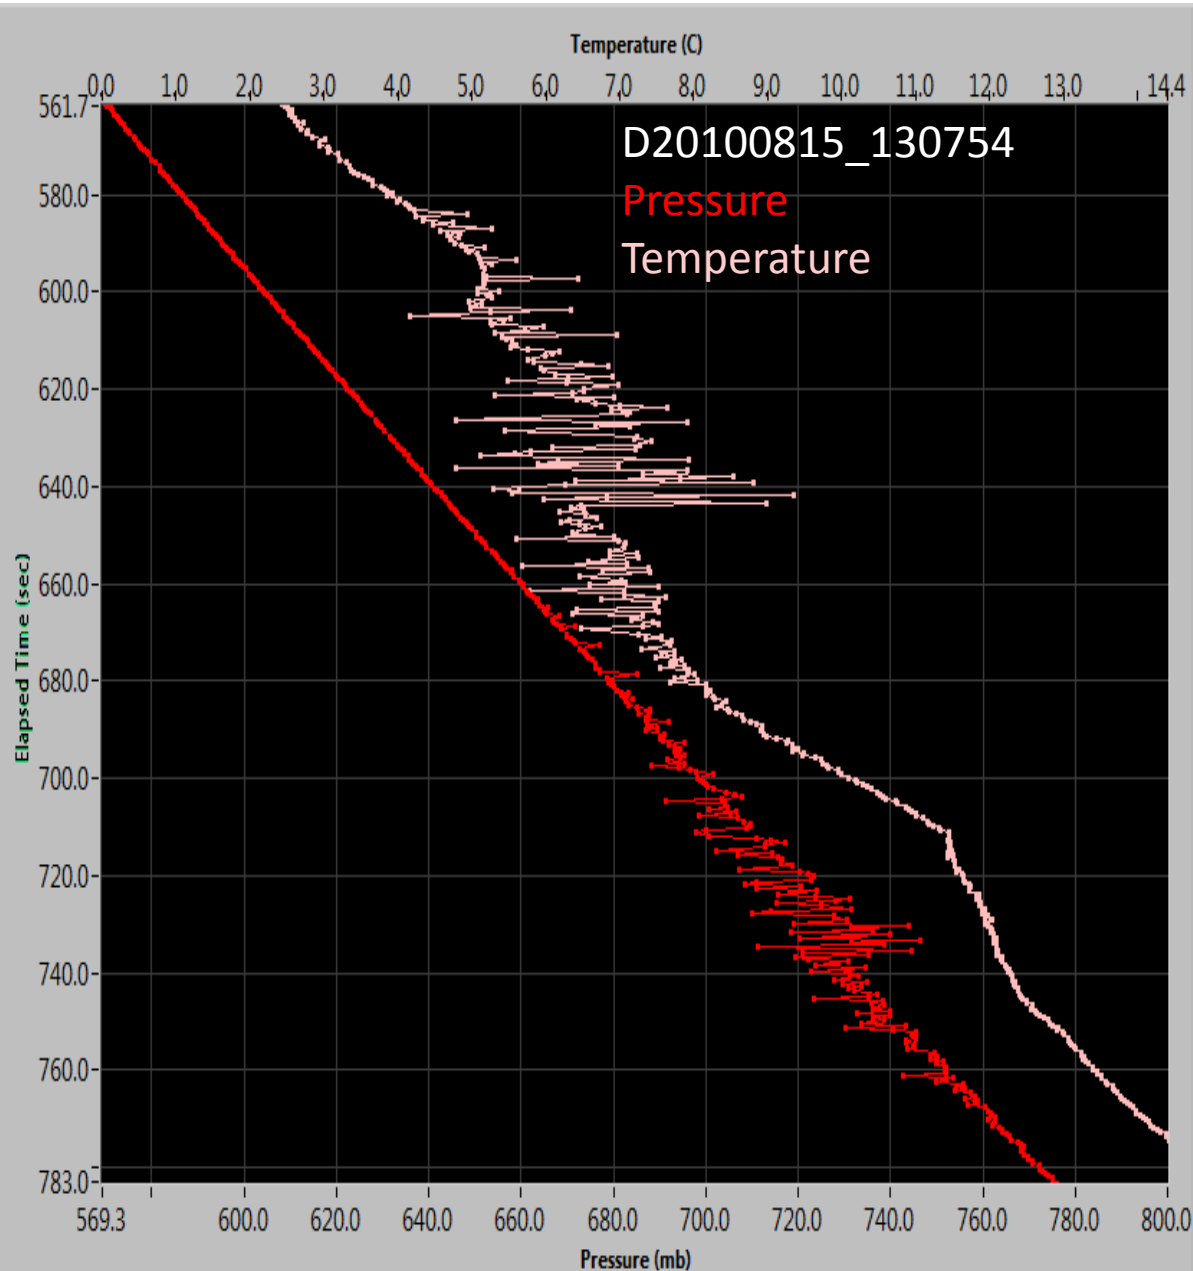
# PTU Oscillations

11 soundings had varying degrees of noise or oscillations in the pressure, temperature and/or RH data.

RF energy from the dropsonde transmitter antenna inducing noise in the PTU module which was caused by a manufacturing change in the PTU module and tolerance of electronic components in the dropsonde.

- The problem was resolved in the manufacturing for new sondes.
- These files were processed through ASPEN with more restrictive QC parameters than are typically used. This removed virtually all evidence of the oscillations. As a result, these soundings can be data sparse.

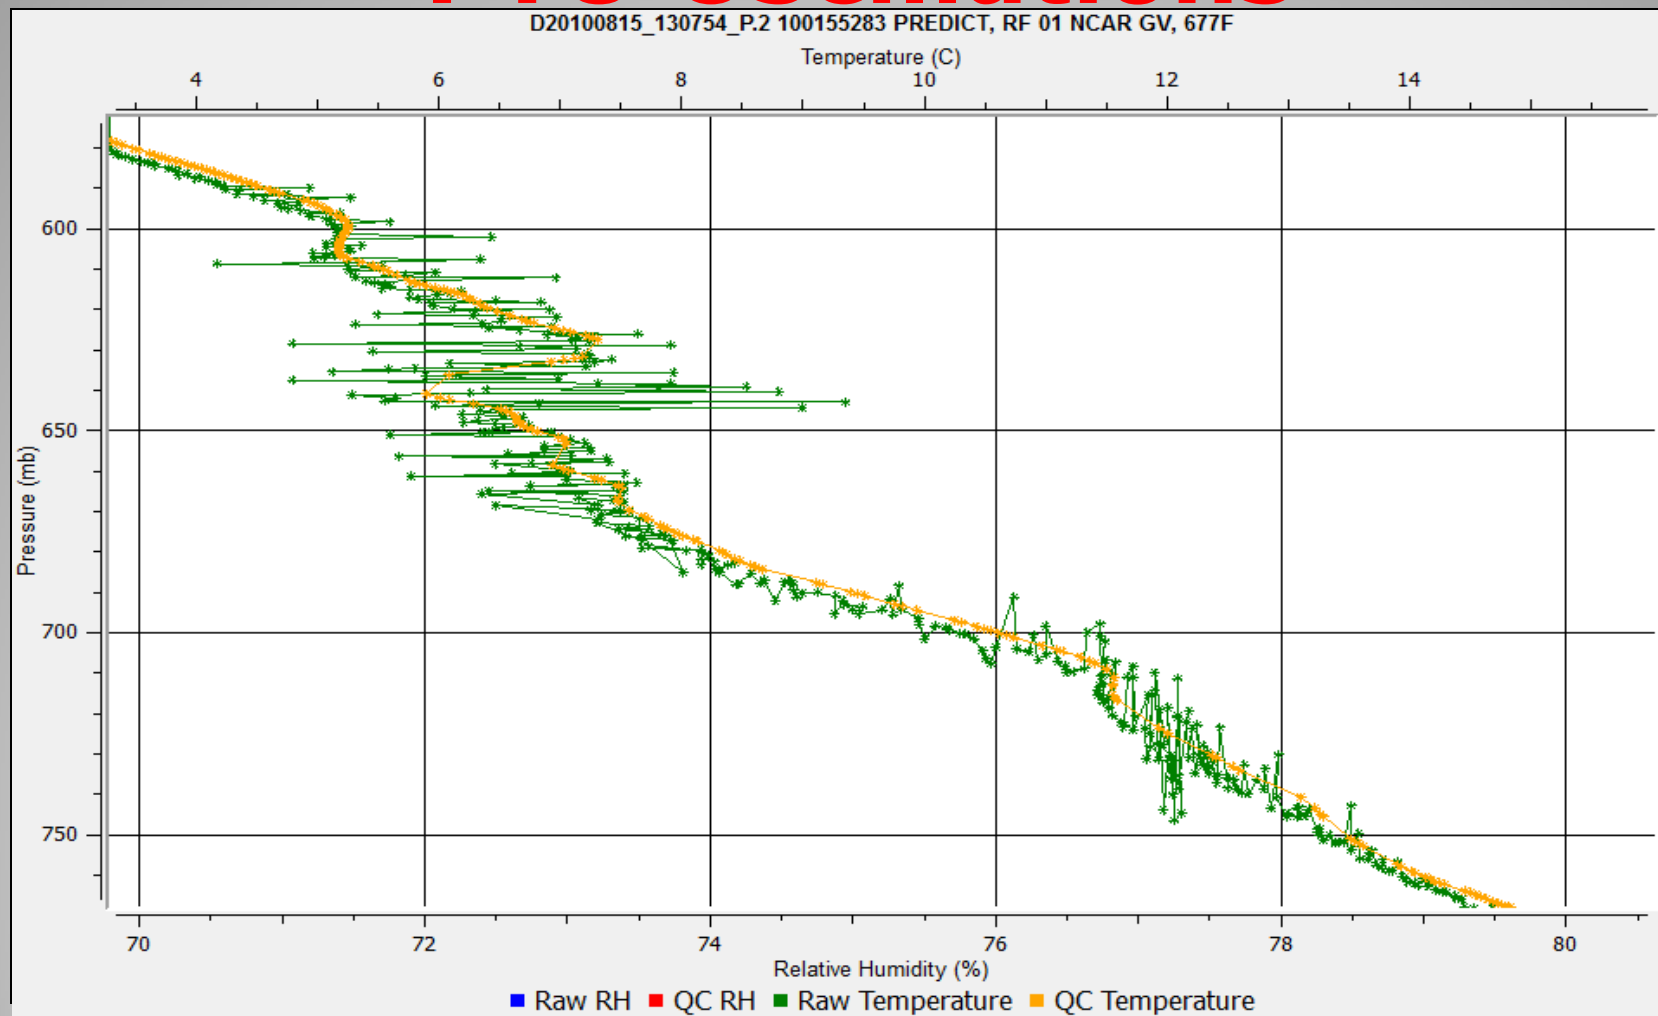
# PTU Oscillations

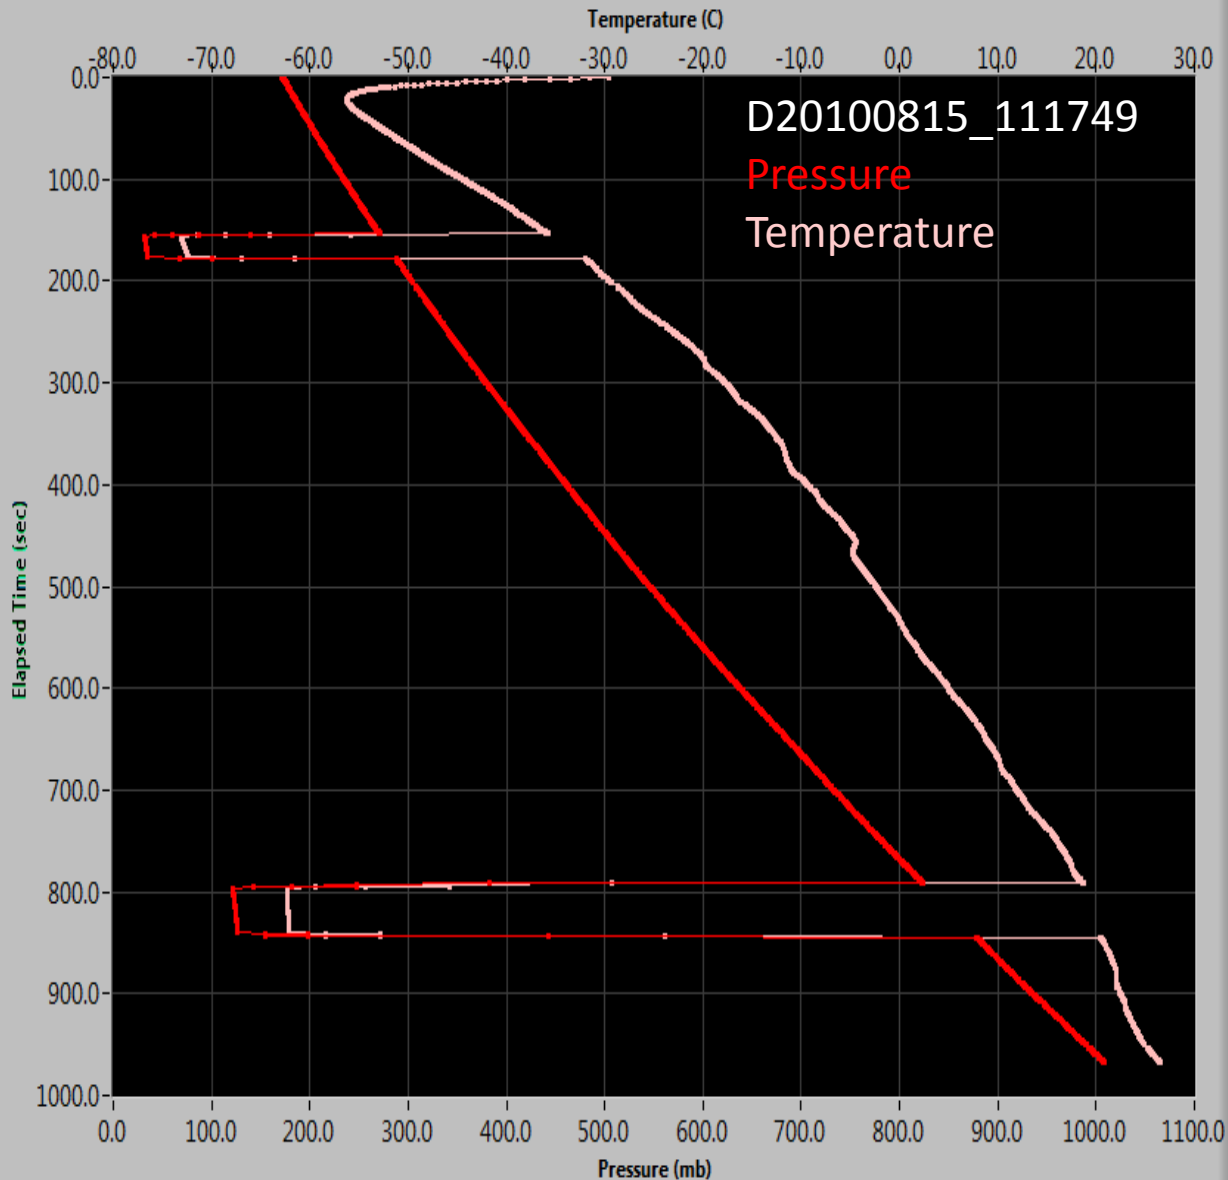
# PTU Offsets

**Nine soundings had large, temporary offsets in pressure, temperature and humidity.**

**Vaisala PTU firmware problems.**

**Vaisala fixed it in 4/2010. The PTU data during these periods was set to missing.**
