RAF VUV CO Measurements

Teresa Campos, Clifford Heizer, and Frank Flocke

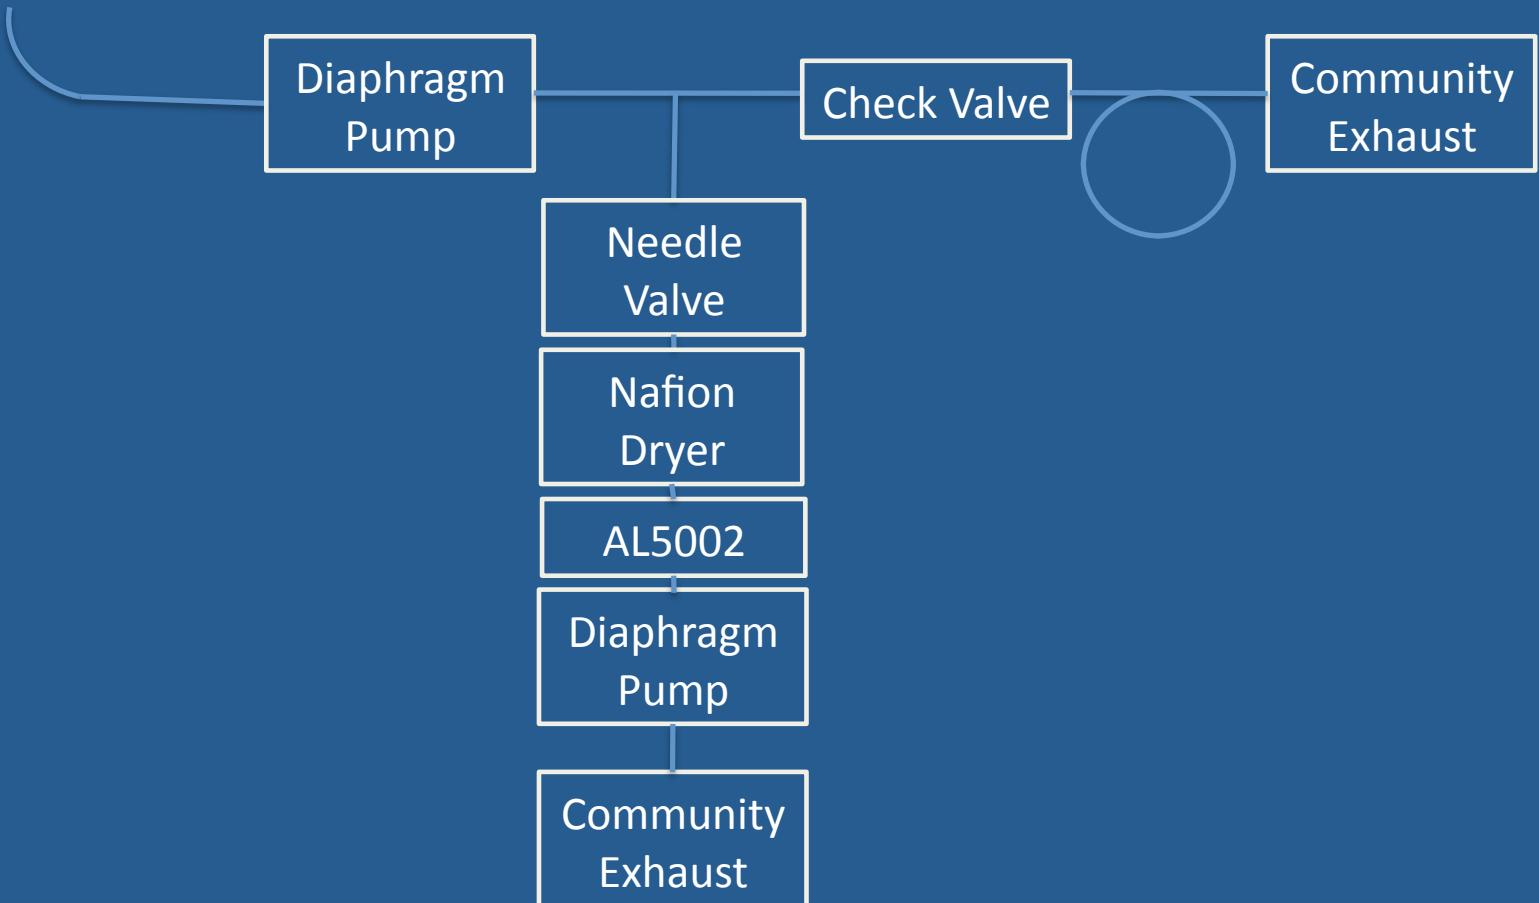
HIPPO-1 Inlet configuration

- Chemical interference observed during TF01.
- Changes to inlet manifold plumbing to address this problem.
- Time and certification requirements did not allow for major changes.
- Modifications created a ‘memory tube’ that resulted in a long averaging volume resulting and poor instrument time response.

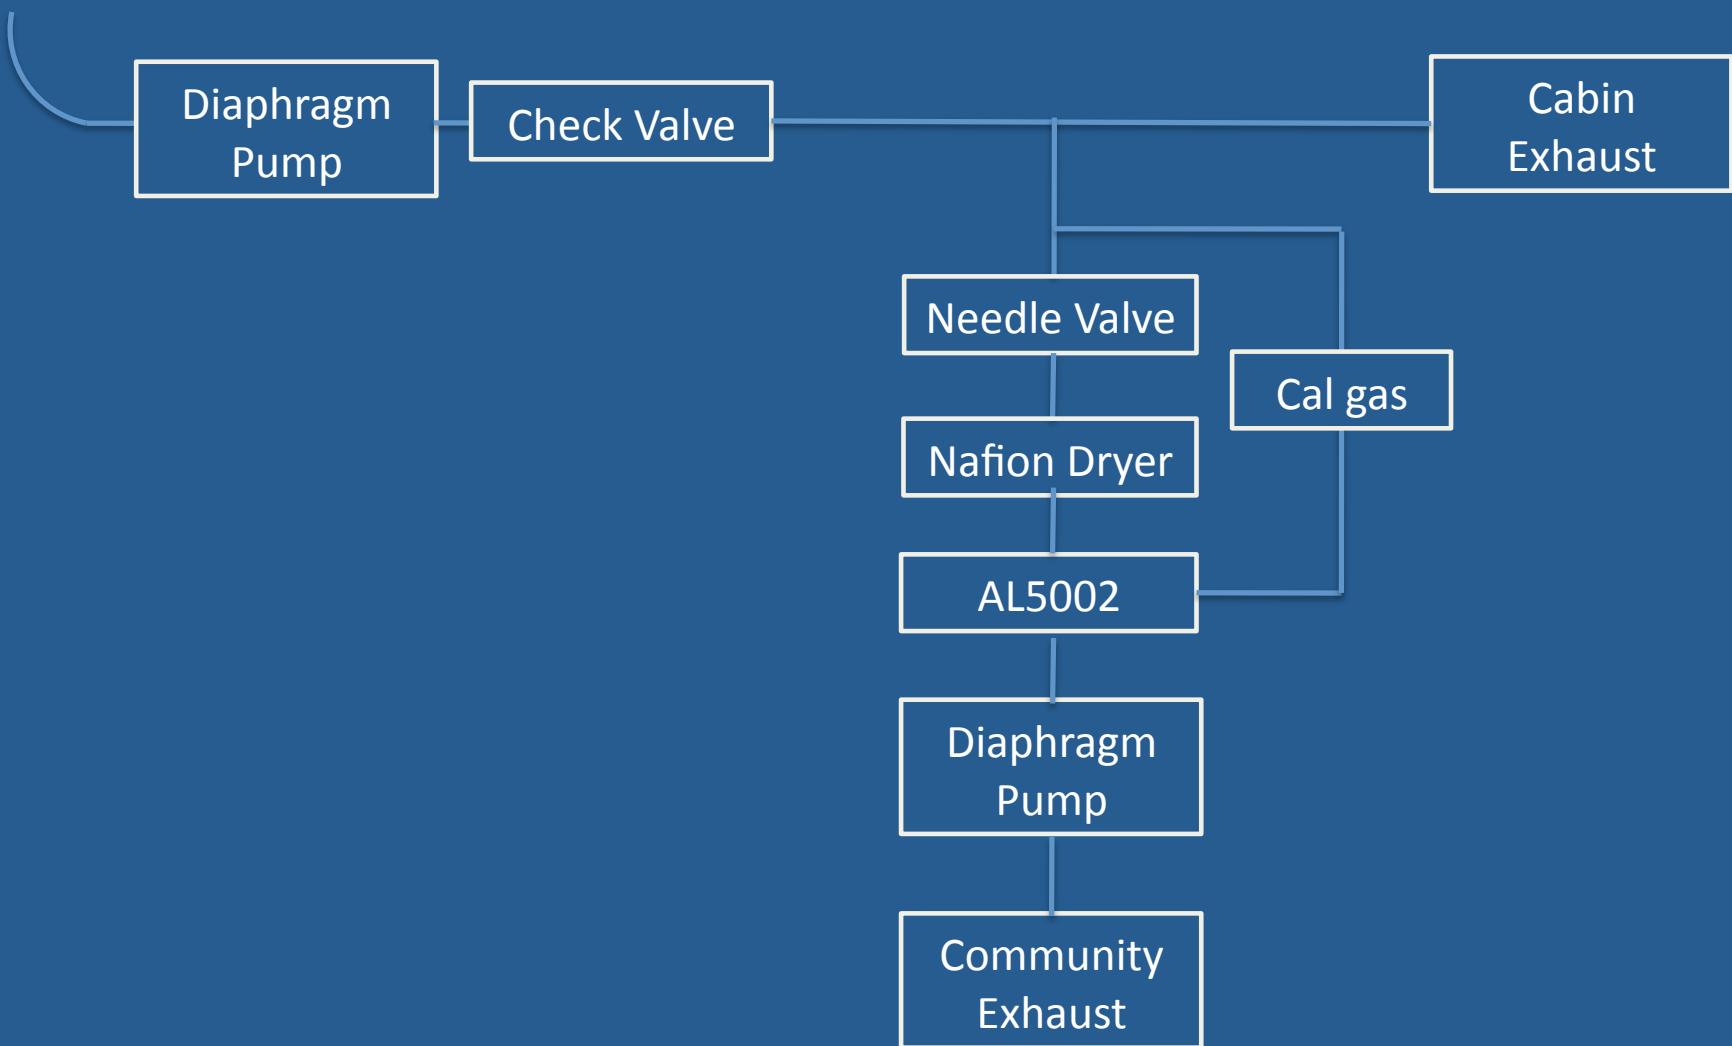
HIPPO-2 Inlet configuration

- Changes Implemented After HIPPO-1:
 - vent to cabin, isolated from community exhaust
 - shorten line length by > 20 feet
 - insert calibration line just downstream of pickoff point
- Additional tweaks after HIPPO-2:
 - sent dedicated support staff to 2 ground stops
 - change gas module line materials

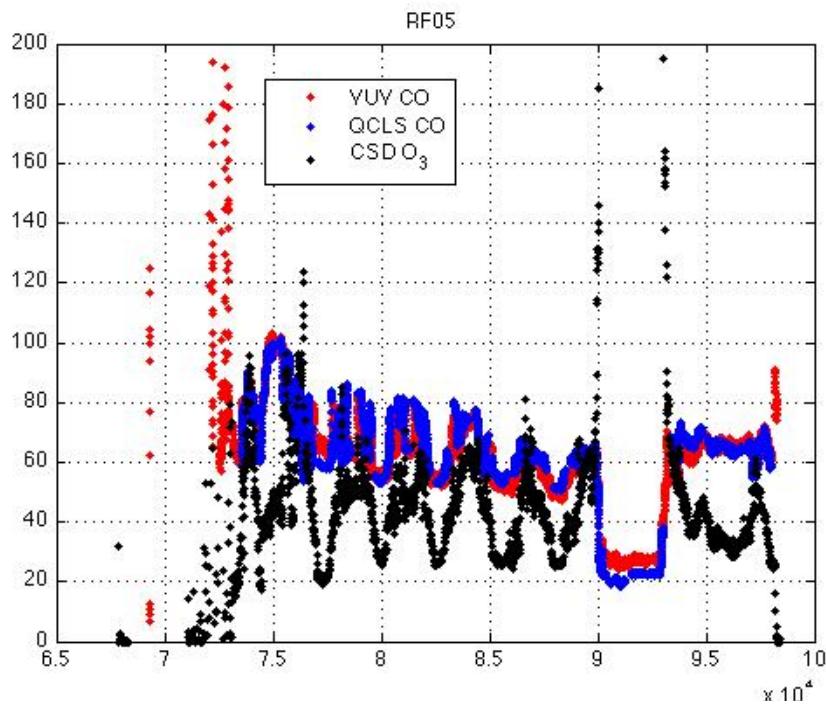
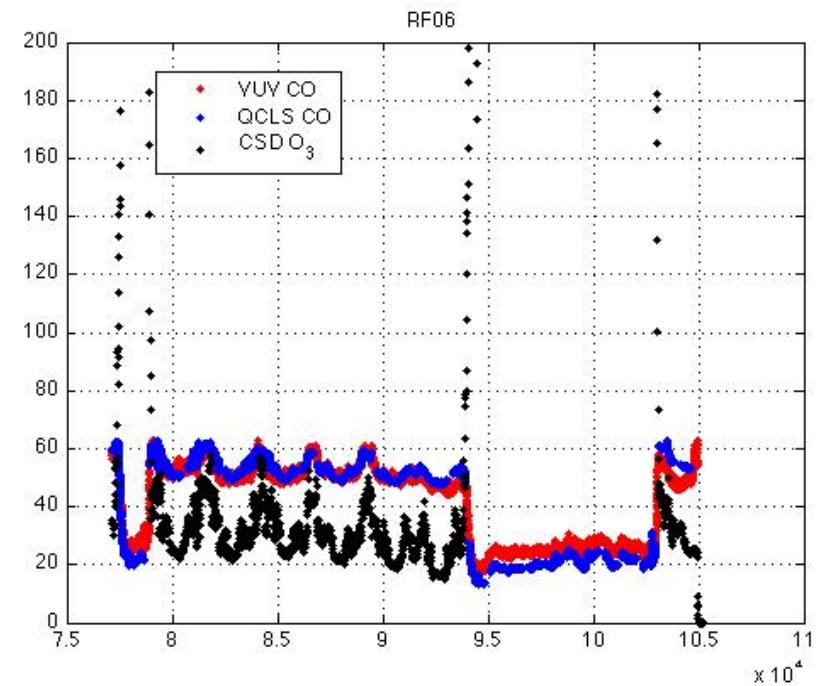
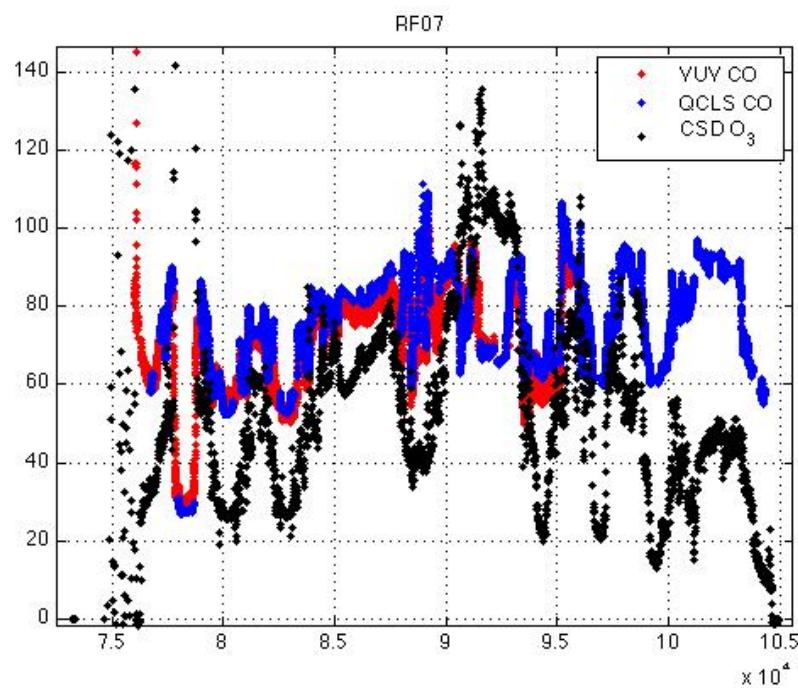
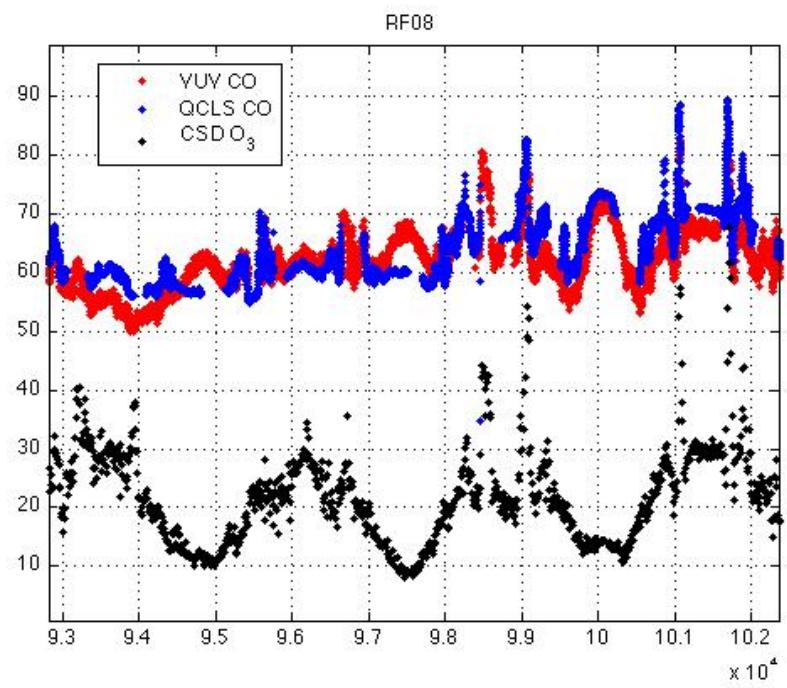
Improved Agreement

Flight Number	HIPPO-2 RMS Difference (QCLS-VUV)	HIPPO-3 RMS Difference (QCLS-VUV)
1	4.1 ppbv	5.2 ppbv
2	11.6	13.9
3	9.5	12.8
4	4.0	7.2
5	4.2	1.2
6	3.7	1.1
7	6.0	1.3
8	4.9	2.3
9	9.8	6.2
10	11.0	5.2

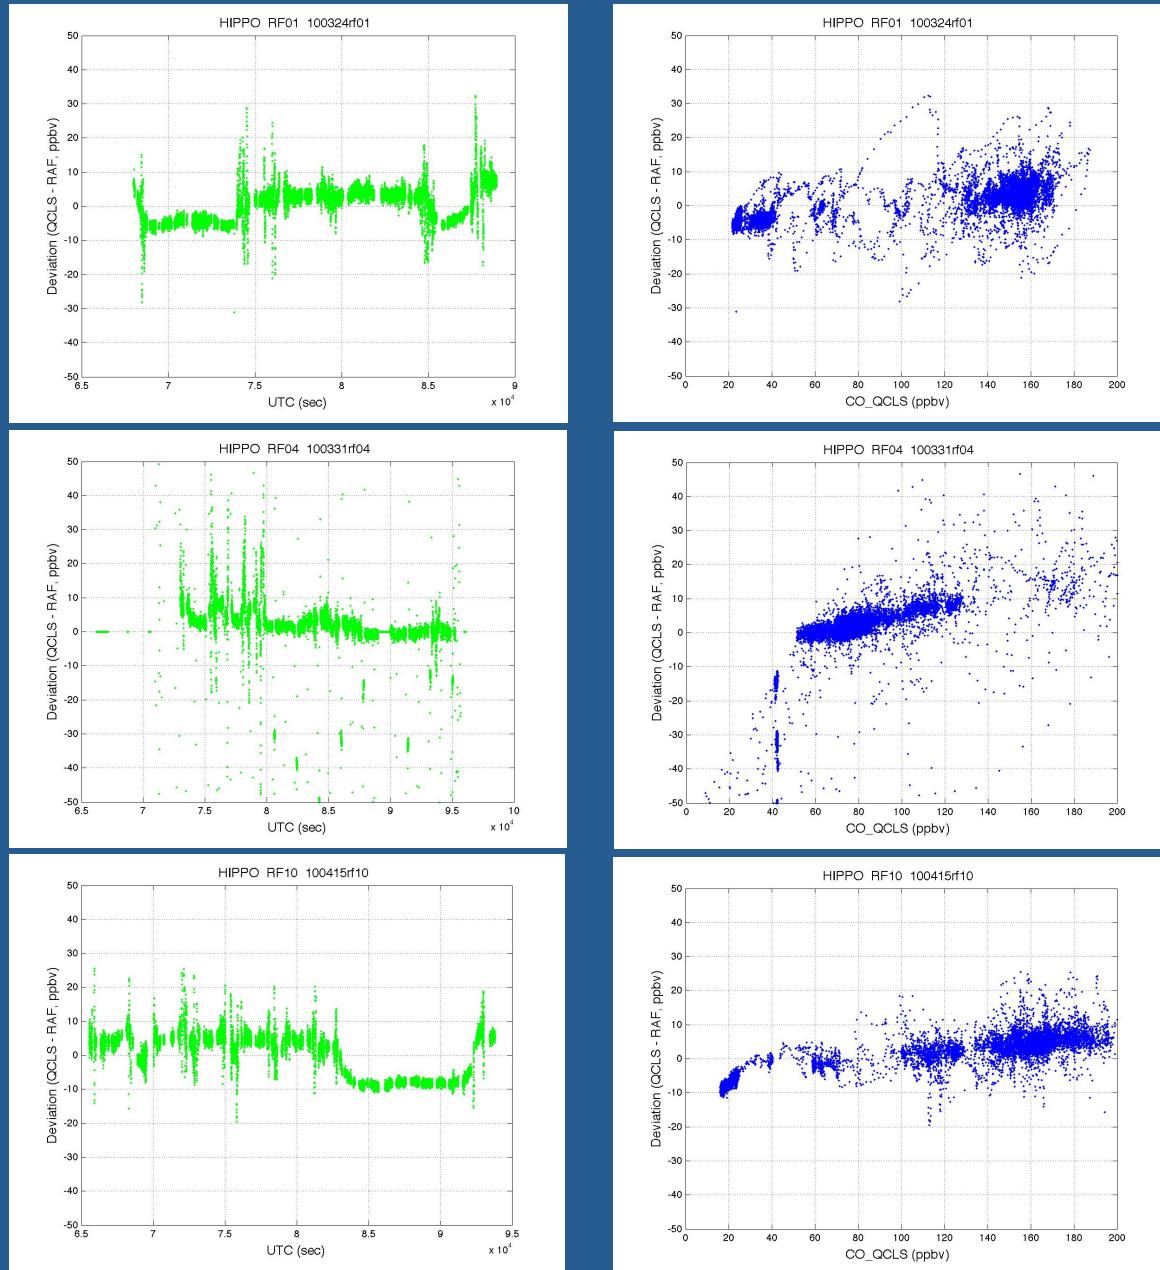
HIPPO-3 Real Time Data Very Preliminary Intercomparison

- For HIPPO-2 and -3, agreement with QCLS instrument is very good
- Where there are differences, typical magnitude is within a ± 10 ppbv range
- No adjustment has been made for the difference in time response,
- Nor for lab characterizations of remaining altitude-dependent cal slope changes.
